Repairing LitterMaid Self-Cleaning Litter Box

This repair project involves replacing malfunctioning microcontroller chip in LitterMaid Mega self-cleaning litter box with a Microchip PIC microcontroller and redesigning its firmware. It is shown how to embed a new microcontroller onto the original board and a detailed description of the new firmware algorithm is presented.

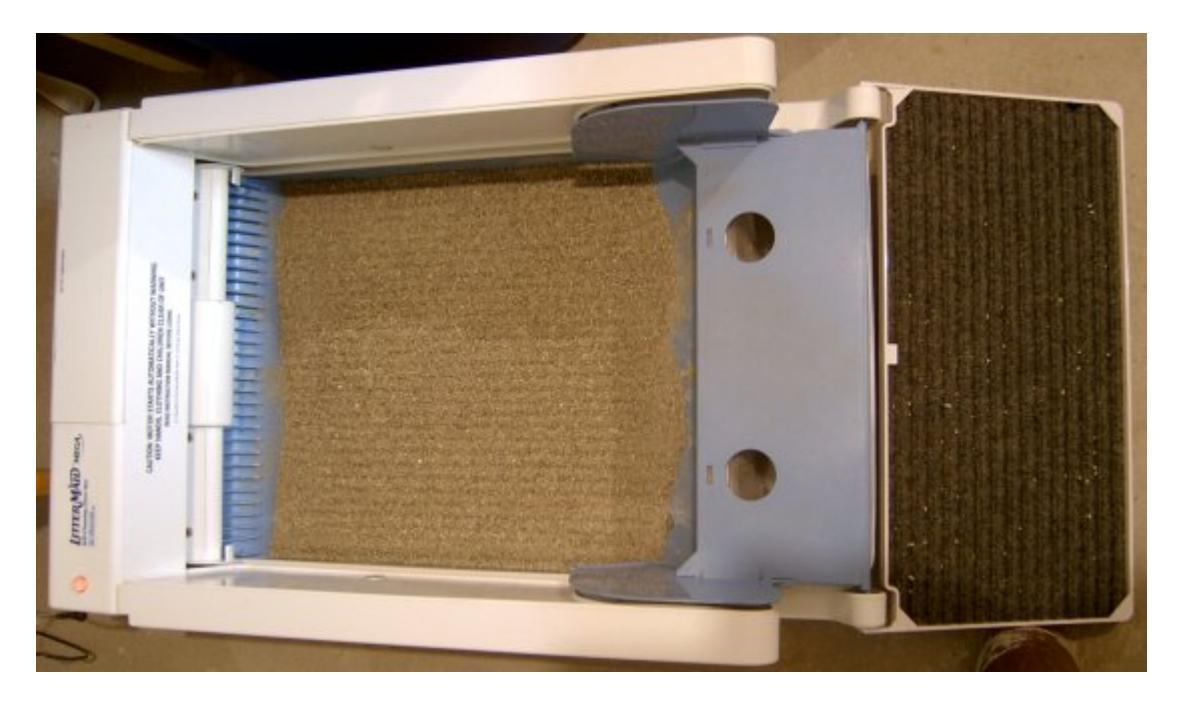
Figure 1: My LitterMaid Mega older model

During the past several years we were using for our cat a self-cleaning litter box manufactured by LitterMaid. Although this device does not provide a perfect cleaning of the box so that you do not need to touch it any more for a manual cleanup, it made our life somewhat simpler. However, one day it stopped working for an unknown reason: the power LED was steady on but the rake refused to move.

My litter box model (see Fig. 1) is pretty old and is probably not manufactured any more. The modern ones come with more features like real-time clock which allows you to disable automatic cleaning at some times (e.g., nights), and air ionizer for reducing the smell. Therefore, the technique described here might not be directly applicable to newer models. I have never opened newer models yet and am not aware of what is inside. However, I hope that my experience could be applicable anyway.

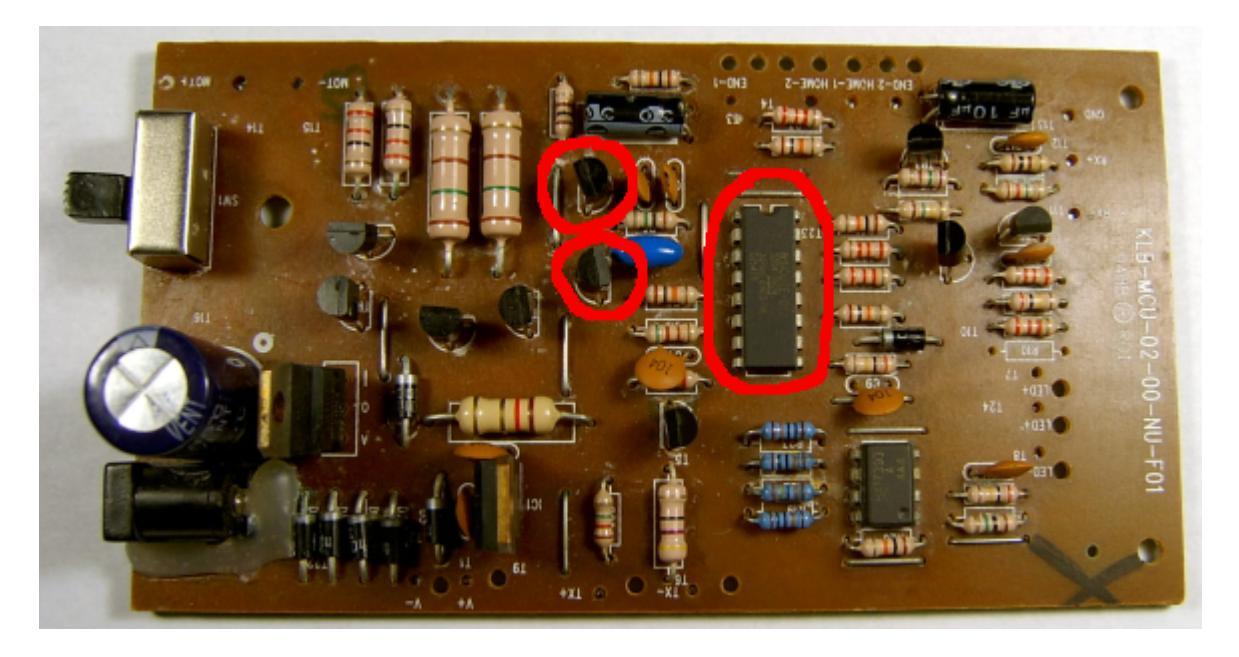
Figure 2: Damaged components: two transistors and microcontroller IC

The device is assembled on a single printed circuit board (PCB) shown in Fig. 2. After careful examination of all components I figured out that two transistors TR6 and TR7 of type 2N3904 were burned out and the microcontroller IC3 showed no reaction to signals applied to its pins. These components are are circled in Fig. 2.

Note that in other cases the set of damaged components can be different. In my case replacing transistors was not a problem, but the device still did not work after this, so a microcontroller replacement was needed. The problem was that I could not identify the microcontroller (MCU). But even if I could, it won't help me much, since any MCU must be programmed with firmware and I have no development tools for this MCU. Moreover, the manufacturer does not provide any firmware for download. So, I decided to replace the original MCU with another one that I can handle (Microchip PIC16F684) and develop a new firmware for it by myself.

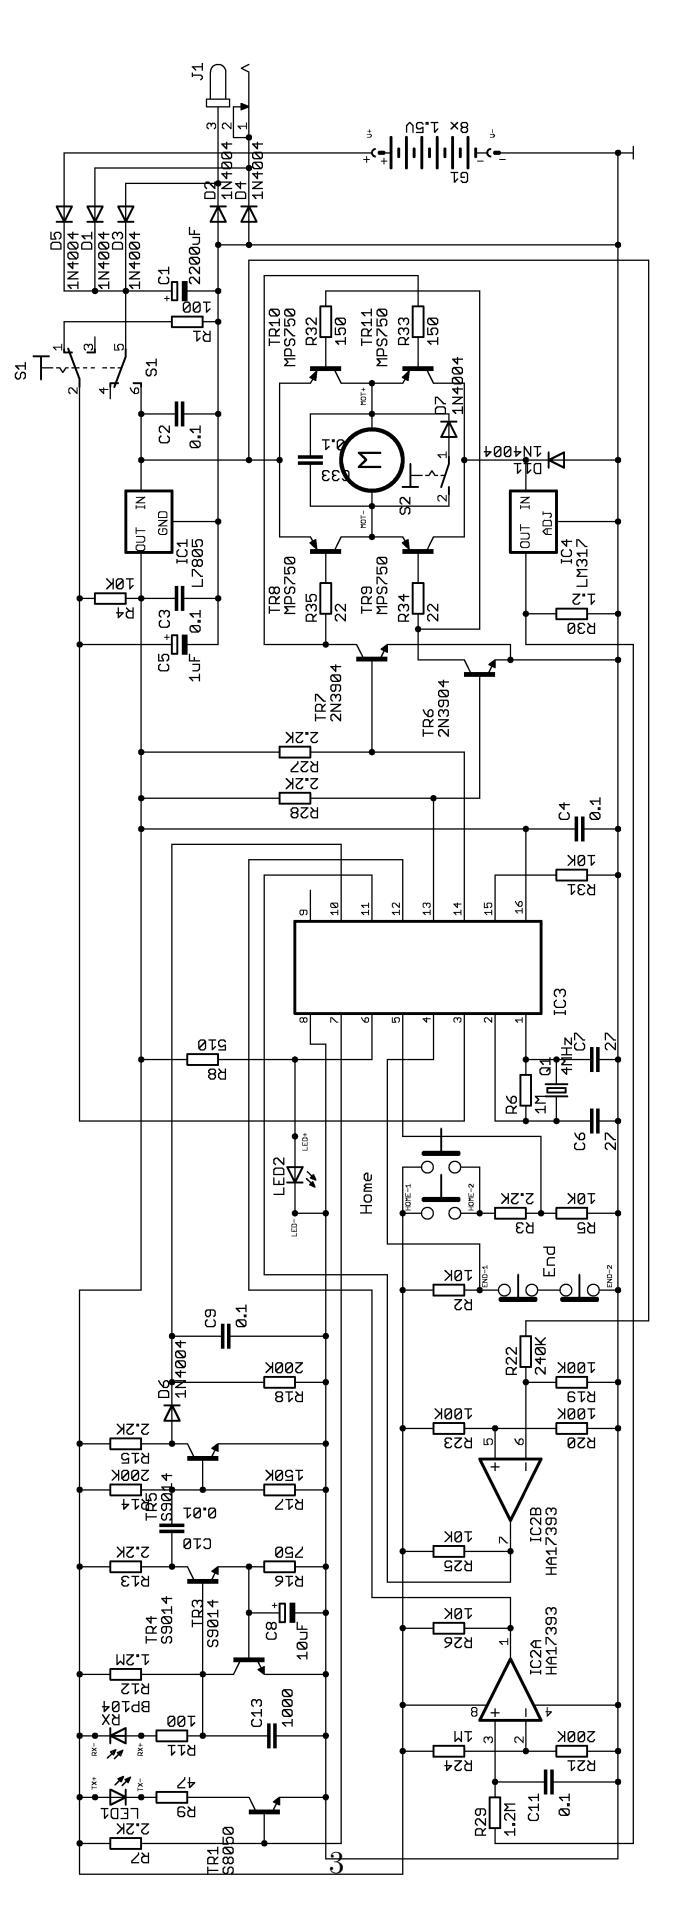
Figure 3: Original schematic

By examining the PCB I came up with the schematic shown in Fig. 3. The numbering of components on the schematic matches the one on the PCB.

Checking for pet presence in the box is accomplished by an infrared emitting diode LED1 and IR receiving diode RX. The transmitter is switched by transistor TR1, whose base is driven by a square-shape waveform from pin 7 of MCU IC3. The frequency and duty cycle of this signal is about 10 kHz and 50%, respectively. The receiver's output signal is pretty weak and needs to be amplified, for which transistors TR3 - TR5 are used. The amplified signal is forwarded to the peak level detector on components D6, R19, and C9. In case of no blocking obstacle between IR transmitter and receiver (no pet in the box) the voltage at the peak detector output is about 4.5V. It drops down to 0V by blocking the IR ray.

Transistors TR8 - TR11 form an H-bridge that controls the direction rotation of motor M. Transistors TR6 and TR7 amplify current for driving the H-bridge. When the rake is steady the voltage at MCU pins 13 and 14 is close to 0 and all transistors TR6 - TR11 are closed. To move the rake forwards (for cleaning) pin 13 of MCU turns into a high-impedance state, resulting in opening of TR6 which in turn opens TR9 and TR10. For moving the rake back MCU outputs 0 at pin 13 and drives pin 14 into a high-impedance state. This results in opening of TR7 and as a consequence of TR8 and TR11. The voltage polarity applied to the motor changes to the inverse one resulting in reversing its rotation direction.

The final position of the rake as it moves forwards is registered by a pair of buttons *End* (see Fig. 3) located inside the device side panels. At the final position the buttons get open and the voltage at MCU pin 4 raises up from 0 to 5V. Similarly, the home position of the rake is registered with another pair of buttons *Home*. As the rake reaches its home position these buttons get close resulting in dropping the voltage at pin 5 from 4.4V down to 0.

The motor moving the rake is equipped with a gearbox, resulting in a pretty high torque so I can barely stop the rake with my hands. Nevertheless, sometimes even this power becomes insufficient for moving the litter out and the rake jams. If this happens, the current through the motor and H-bridge noticeably increases. To protect them from burning out the designers use voltage regulator LM317 (IC4). Since the adjustment terminal of LM317 is grounded, the voltage at its output is close to the input one. As the current drawing by the motor increases, the one through IC4 and R28 increases too. IC4 limits the current at the level of approx. 1.5A thus protecting the H-bridge and the motor.

At the same time, increasement of motor's current is registered by comparator IC2a which monitors the voltage drop on R29. As the current goes above 0.7A this voltage drop exceeds 0.83V (determined by R21 and R24) the comparator output raises up from 0 to 5V. The low-pass filter R29 - C11 prevents the comparator from reporting short peaks of drawing current (below ca. 70 msec) that can be caused by transporting heavy loads

by the rake or by reaching the terminal positions. Furthermore, triggering an overload is also provided by a bumper located at the back of the rake. This way pets incidentally appeared behind the rake moving to the home position get protected from smashing. The bumper closes button S2 (mounted inside the rake), which triggers an overflow signal at the output of IC2a only when the rake moves backwards. This is accomplished by diode D7 which blocks button S2 when the rake is moving forwards.

The device can be powered from a wal-wart power supply or from batteries. The input voltage is rectified by D1 - D5 and stabilized by IC1 of type 7805. The input voltage is monitored by comparator IC2b. If the voltage drops below 8.5V (determined by R19 - R20 and R22 - R23) the output of IC2b raises up from 0 to 5V. This information is used by MCU for controlling the rake. Turning the device on is performed by switch S1. Its lower (on schematic) contacts break the input voltage, while the upper ones probably serve for resetting the MCU.

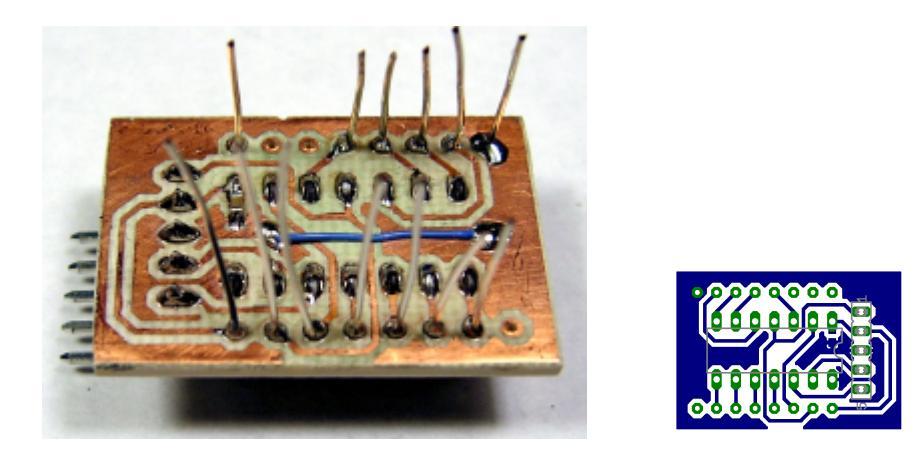
Figure 4: Auxiliary board carrying PIC16F684

As it is mentioned above I replaced the original MCU with PIC16F684. This part has only 14 pins vs. 16 in the original one and has incompatible pinout. To resolve the last problem I mounted the new MCU on a small home-made PCB shown in Fig. 4.

The right image in Fig. 4 is a detailed view of the PCB traces which are located on its bottom side. The blue jumper connects the filled (ground) areas on PCB.

The board size is about 2×3 cm. It has 16 pads corresponding to the ones of the original MCU. The auxiliary PCB pads are connected by short wires with the corresponding MCU pads on the original PCB (the original MCU has to be removed from PCB, of course). This way the auxiliary PCB is assembled about 1 cm above the main PCB and the constructions is pretty stable. Fig. 5 and Fig. 6 show the original MCU on PCB and its replacement, respectively.

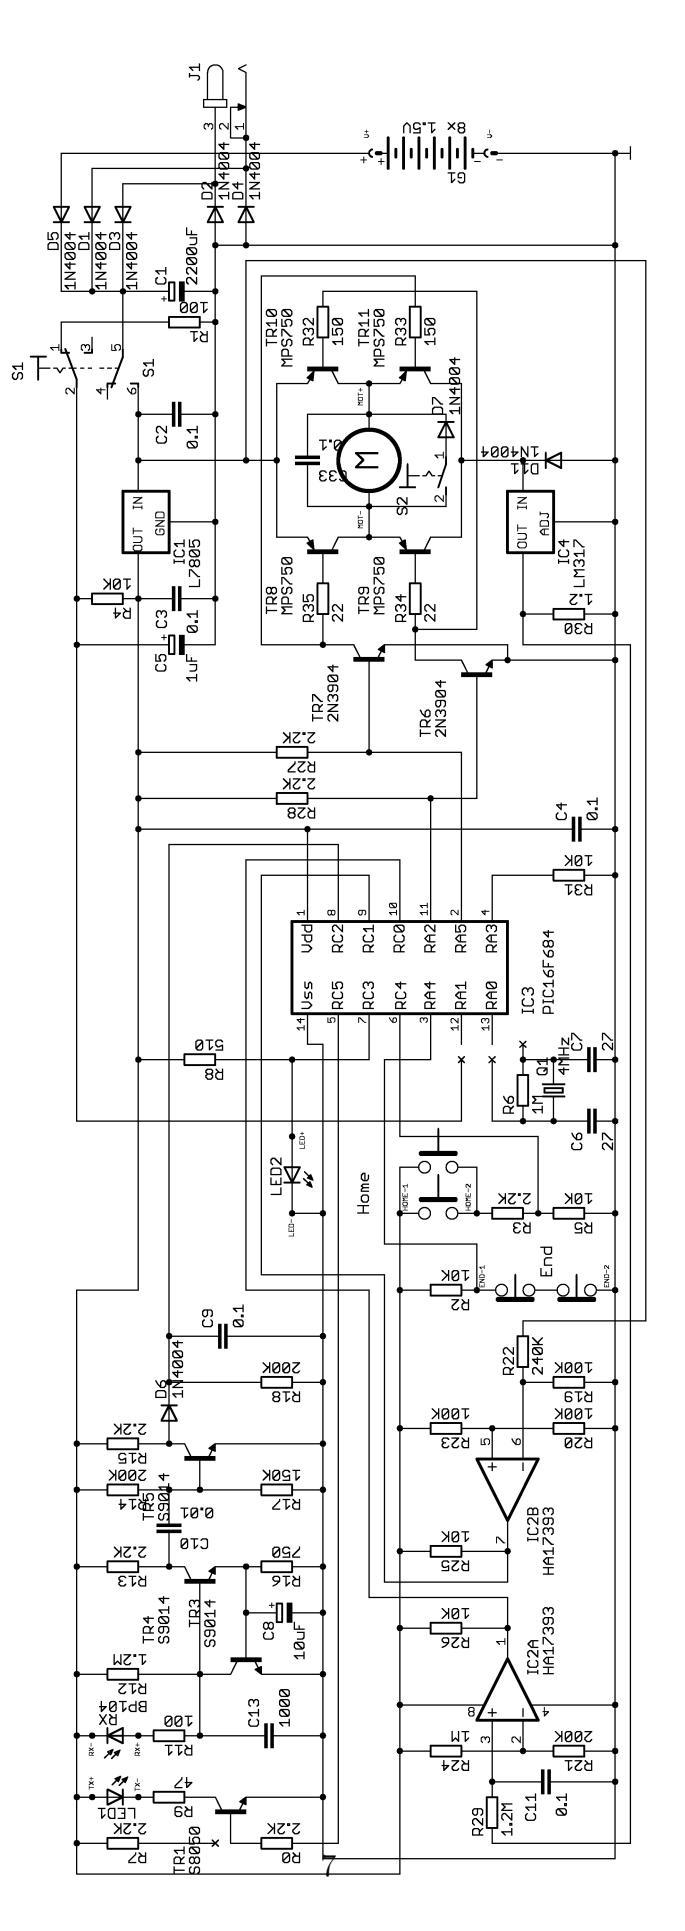
Figure 7: Modified schematic

The 5-pin connector on the auxiliary PCB is intended for in-circuit programming of PIC16F684. This was very handy, since the firmware was reloaded into it many times during debugging. By the way, it turns out that my PIC programmer was unable to power the entire circuit during the MCU programming process. I resolved this problem by powering the device from its own power supply during programming. This way the modified schematic becomes as it is shown in Fig. 7.

Since PIC16F684 has pretty stable internal clock oscillator, the elements Q1, C6, C7, and R6 (that served for clocking the original MCU) are not needed and they are not connected to my board. I also did not use the reset circuitry R1 - C5, relying on the one built in PIC16F684. The broken connections are indicated by crosses (\times) in Fig. 7.

The last modification concerns resistor R7. It was disconnected from the base of TR1 by cutting off the corresponding trace on the PCB. Instead of it a new current-limiting resistor (R0 in Fig. 7) is added. For this the PCB trace connecting the base of TR1 with MCU was cut off and a small SMD resistor in package 0603 (not shown on photos) was mounted over the cut. It is possible to use a regular resistor with axial leads.
